**Daily Drilling and Scientific Report for
IODP3-NSF Expedition 501
New England Shelf Hydrogeology, 2025**

12th June 00:00 – 12th June 24:00 East Daylight Time (UTC -4)

Position 40.8746°N, 70.2697°W @12:00 EDT 8th of June
IODP-MSP borehole M0111C
Prospectus borehole MV-03C
Water Depth: 44m

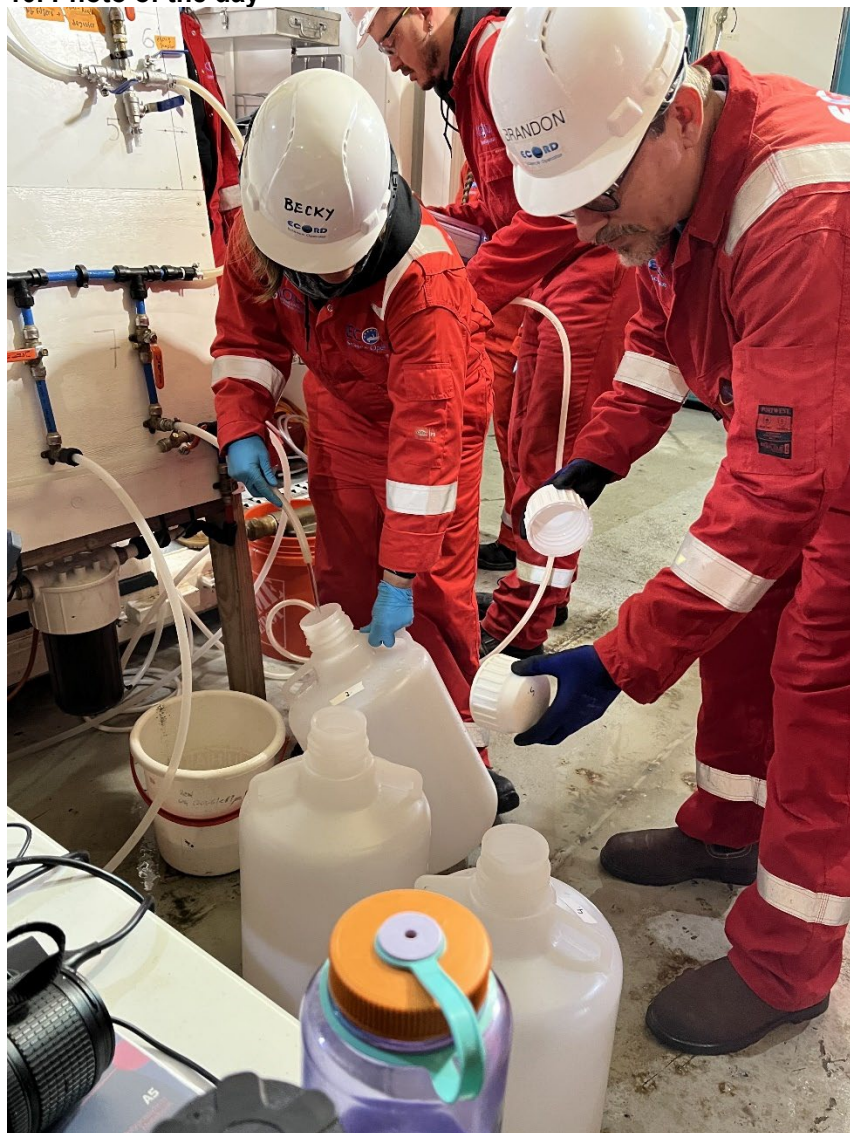
Figure 1: Water sampling during the pump test (ARNHARDT@ECORD_IODP3_NSF_pumptest_sampling)

Two Alien cores were recovered just after midnight, and the string was filled with sea water in readiness for water pumping. The packer was installed and pumping commenced to purge the string of sea water. A steady flow of approximately 6 L/min was achieved. Samples were collected for geochemistry and microbiology, with the noble gas sampling regime ready to commence after midnight.
