**Daily Drilling and Scientific Report for  
IODP3-NSF Expedition 501  
New England Shelf Hydrogeology, 2025**

**3<sup>rd</sup> July 00:00 – 3<sup>rd</sup> July 24:00 East Daylight Time (UTC -4)**

Position 40.99783°N, 70.33337°W @12:00 EDT 3<sup>rd</sup> July  
IODP-MSP borehole M0112B  
Prospectus borehole MV-08AB  
Water Depth: 41m

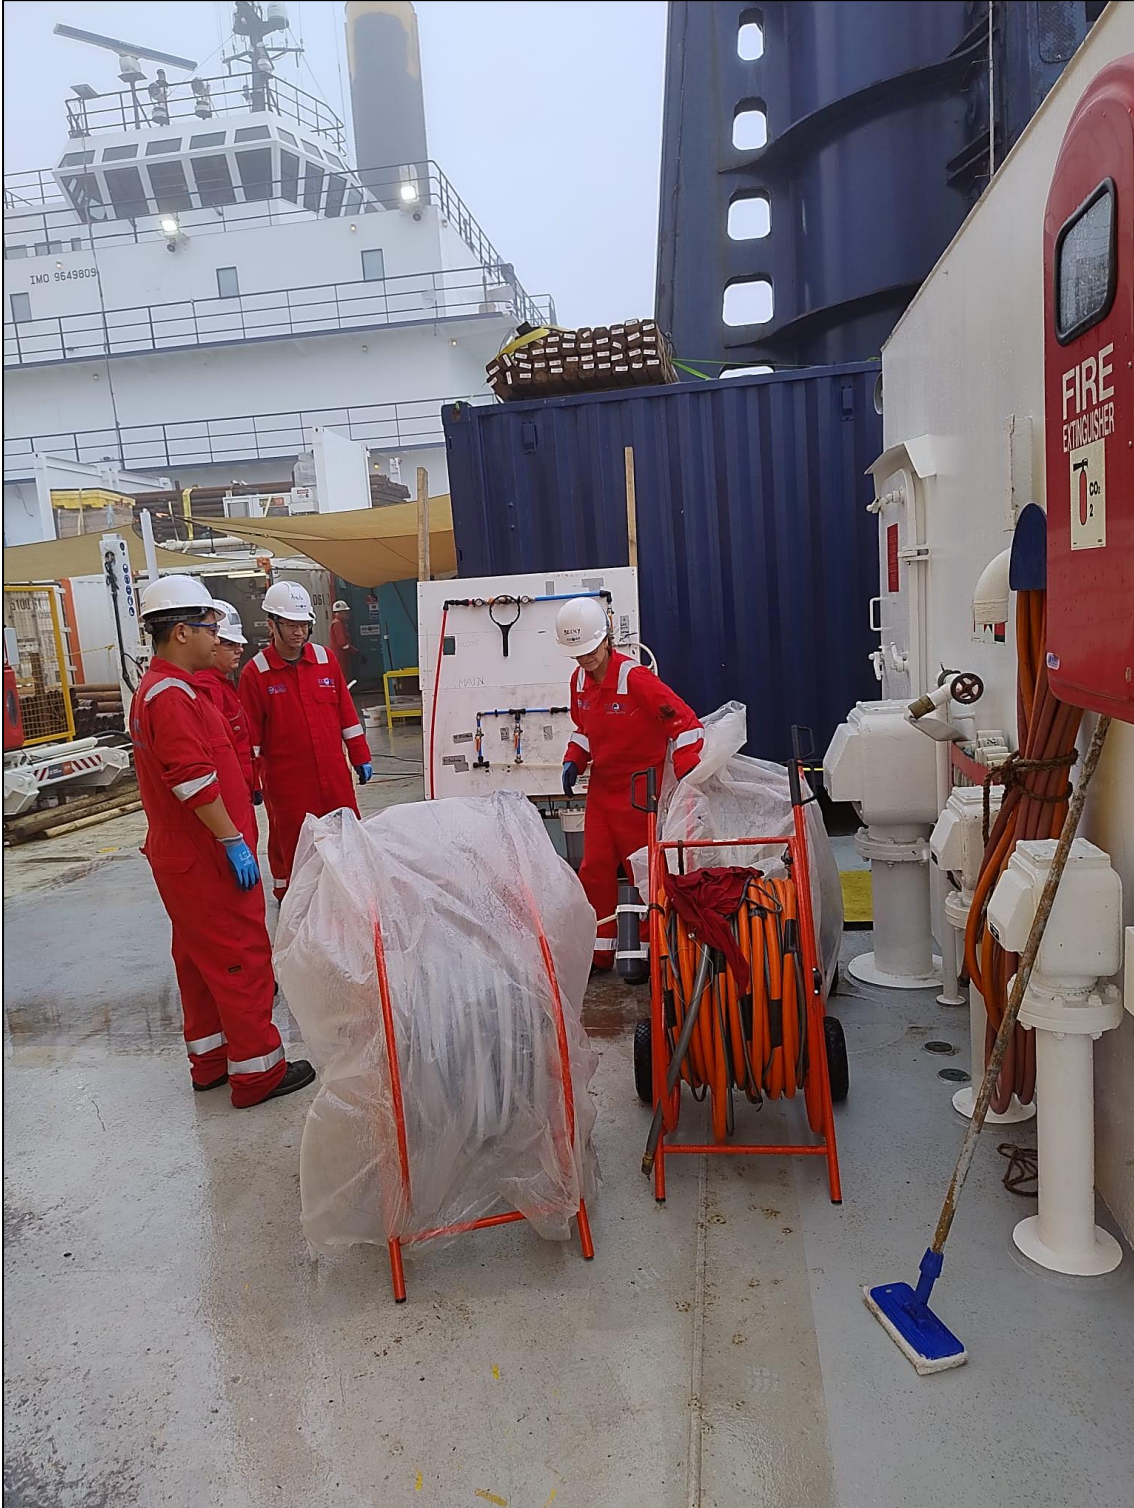
Figure 1 Testing out the setup for the groundwater manifold and pump. STEWART@ECORD\_IODP3\_NSF\_manifoldtest.
