24th July 00:00 - 24th July 24:00 East Daylight Time (UTC -4)

Position 40.618333°N, 70.136972°W @12:00 EDT 18th July IODP-MSP borehole M0113A Prospectus borehole MV-04C-A Water Depth: 53.9m

2. Operations Report

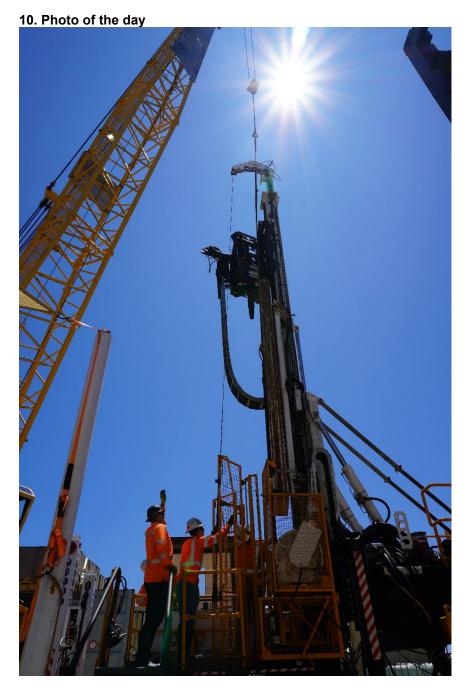
Figure 1: The drilling team deploy the packer downhole in preparation for the pump test at Site M0113A (photo Brickell@ECORD_IODP3_NSF_Packer_install_24.07).

Coring proceeded until mid-morning when a potential aquifer sand was recovered. After proving sufficient depth it was decided to set the packer and attempt to extract water from the formation. The operation was completed in good time without any issues. The initial extraction of water from the drill string proceeded well until late in the evening when the pump failed. Rebound of the water level was recorded but after an hour it was noted there was no further increase in water into the string. Similar situations have been seen in previous tests at different sites. It was decided to recover the MP1 pump and packer assembly and abandon the pump test at this depth.

12:40 – 14:15 Rods tripped to packer depth, water level checked and MP1 pump lowered.
