**Week 1 Drilling and Scientific Report for  
IODP<sup>3</sup>-NSF Expedition 501  
New England Shelf Hydrogeology, 2025**

**19th May 00:00 – 25<sup>th</sup> May 24:00 EDT Eastern Daylight Time (UTC -4)**

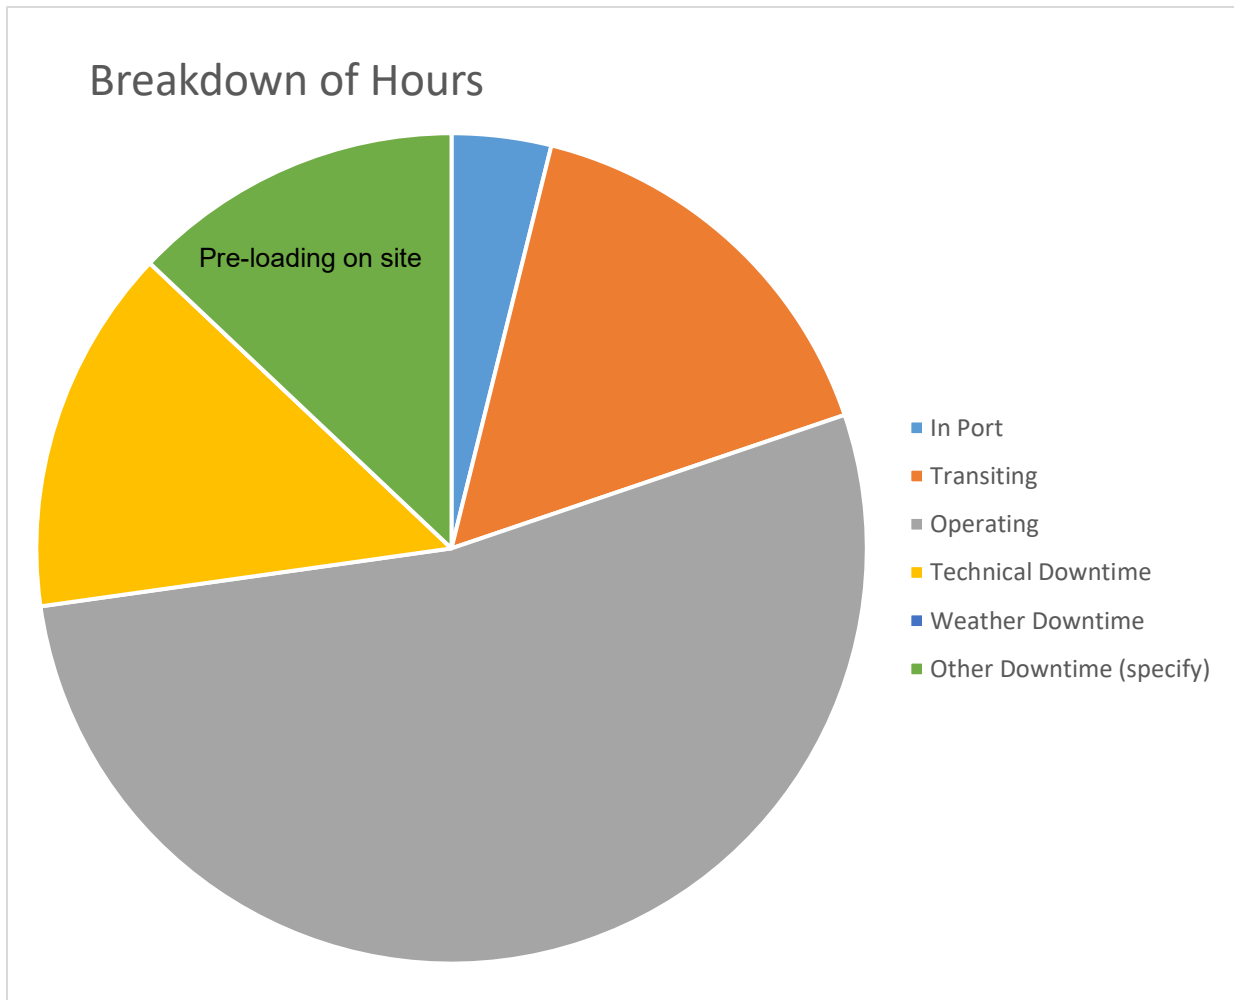
Figure 1: Breakdown of hours from 00:00 May the 19<sup>th</sup> to 24:00 May the 25<sup>th</sup> 2025

A breakdown of hours can be seen in Figure 1, and logs of recovery in Figures 2 and 3.

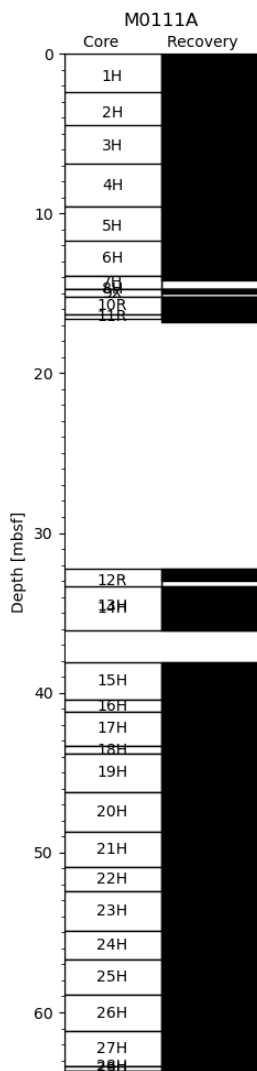
Figure 2: Core Recovery for Week 1 from Hole M0111A (white gaps indicate no recovered core)

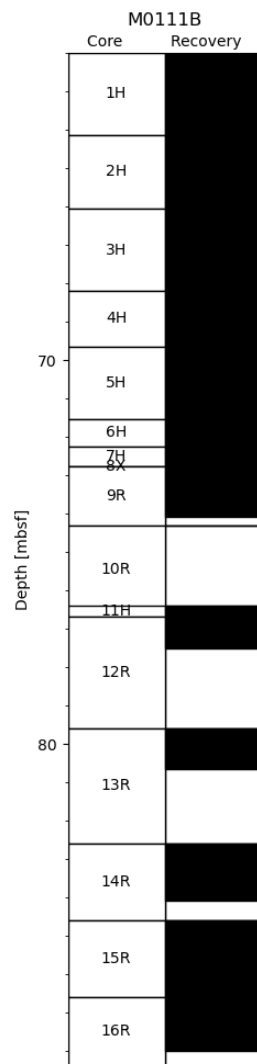
Figure 3: Core Recovery for Week 1 from Hole M0111B (white gaps indicate no recovered core)

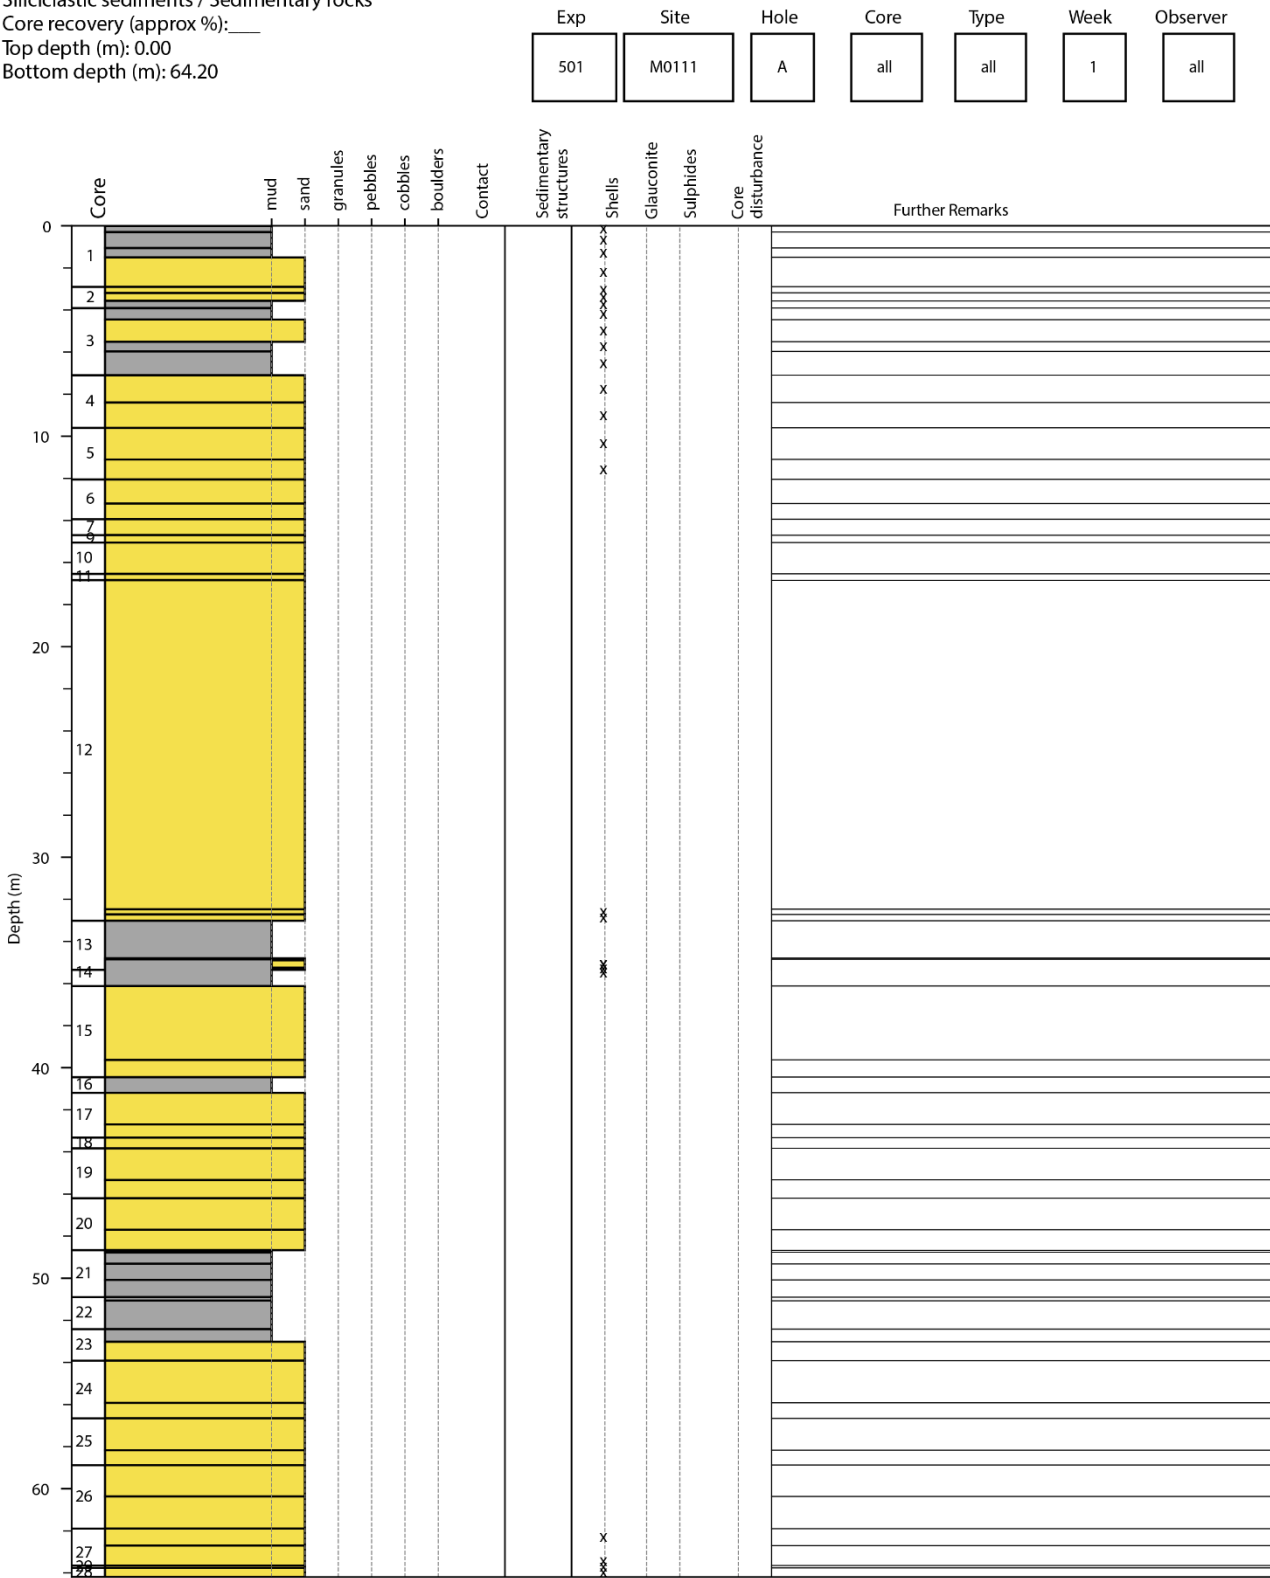
Exp501 VISUAL CORE DESCRIPTION, SECTION DESCRIPTION

Siliciclastic sediments / Sedimentary rocks

Top depth (m): 0.00

Bottom depth (m): 64.20

Figure 4: Visual Core Description (remotely observed, through-liner) for Hole M0111A

The sedimentology team provided a preliminary lithological description based on core section photographs taken while the cores were in the liners (Figure 4). Preliminary observations of core from Hole M0111A (0-63.35 mbsf) indicate a predominance of sand or silt/fine sand. Sediment color is generally grey to dark grey, with some intervals of lighter brownish-grey. Shell fragments were abundant from the seafloor to ~15 mbsf.
